Appendix D: Field Notes and Digital Photographs of Representative Buildings

Field notes and photos for:

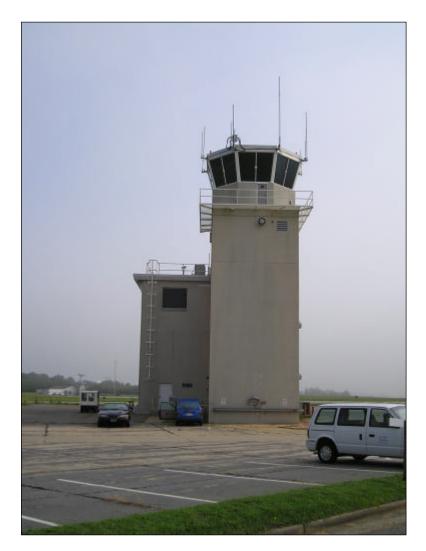
WFF ID# A-1

This five story tall control tower provides air traffic control functions for the main east-west runways at the Wallops Flight Facility. The Operations Building consists of a main tower which is surmounted by a large glass and metal viewing tower. A smaller two-story concrete building abuts the main block at its northwest corner.

The main (south) façade is covered by concrete incised to create a large rectangular block pattern. At the top of the concrete portion of the tower, a metal support railing provides protection for an exterior observation platform. The glass tower is supported by a hexagonal drum. The tower glass is smoke grey in color. Glass panels are held by

vertical metal strips which abut a horizontal metal top. The top of the tower has at least four communication antennae on it.

The south façade of the smaller block is also covered in concrete in a rectangular block pattern. A metal fire escape travels from the top of the building to the ground at the southwest corner. At the ground floor level, a ramp leads up to a metal door, which is framed by a metal guardrail system. A plate glass window is centrally located at the second floor level.

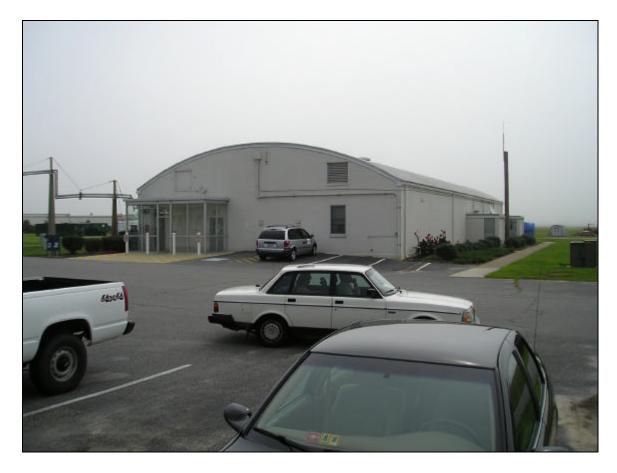
WFF ID# E-7

Located approximately forty yards east of the corner of Stubbs Avenue and Anderson Street on the Main Base portion of the Wallops Flight Facility, this one-story brick building dating from 1945 is notable for its curved roof.

The westernmost gable end serves as the entrance to the building. A modern aluminum frame and glass addition has been placed at the northwest corner to create an airlock for persons entering the building. Two modern doors, painted grey, lead into the building. Above this entryway is a blocked window opening above a concrete lintel. At the southwest corner, a two-oever-two metal modern window punctuates the façade. Above it is a louvered metal vent.

The south façade is punctuated by two simple brick additions, one placed at the center of the façade, and the second towards the southeast corner of the building. Each of these additions is covered by a shallow shed roof. The only distinguishing features are the

aluminum gutter and leader system, and a metal ventilator placed in the center of the roof.

The east gable end functions as the service entrance to the facility. A metal door and transom are located in the center of the façade. To its left and right are larger metal roll-up doors. Above each of these is a metal ventilated window.

The north façade is different in treatment than the south façade. While it is also brick, a metal door and transom have been placed near the center of the façade. To the right of the door are a series of modern two-over-two metal windows. A pair of these windows is also found at the northwest corner. Over all these elements are approximately 12 metal brackets which support utilities for the building. A concrete pad is found at the northeast corner of the building.

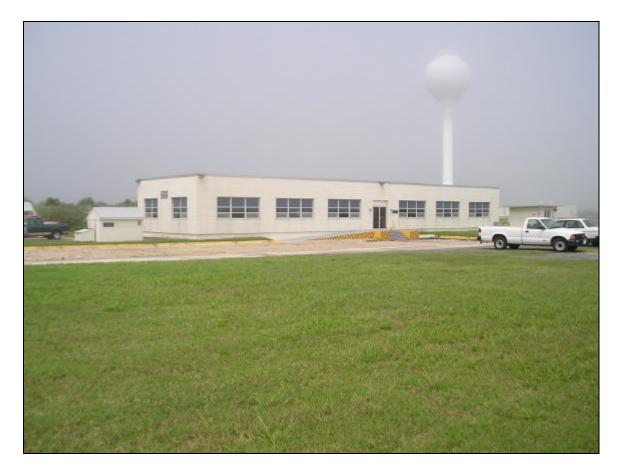
WFF ID# X-55

This simple, one-story, rectangular building is sheathed in concrete with a distinctive block pattern. It cannot be ascertained if this building is frame covered with a concrete skin, or actually concrete block covered with a concrete parging.

The front (east) façade is pierced by a pair of centrally placed entry doors. A thin horizontal line marks an elevated base of the building. A concrete ramp has been constructed leading from an area near the southeast corner to the entry doors. A set of

three steps leads up to a landing, which offers entry through the doors. Two square concrete pads mark the edge of the raised entryway. To the left and right of the entry doors are three rectangular windows. These identical windows are metal, and subdivide the glass into nine panes.

The rear (west) façade of the building is identical to the east, with the exception of entry doors.

The north end of the building also employs the same sheathing and window treatments found in the front façade. Two windows are placed near the southeast and southwest corners. Each smoked glass window is subdivided by metal bands into nine panes of glass. Centrally placed above these windows is one metal vent. The top of the building is marked by a aluminum or other metal roof cap.

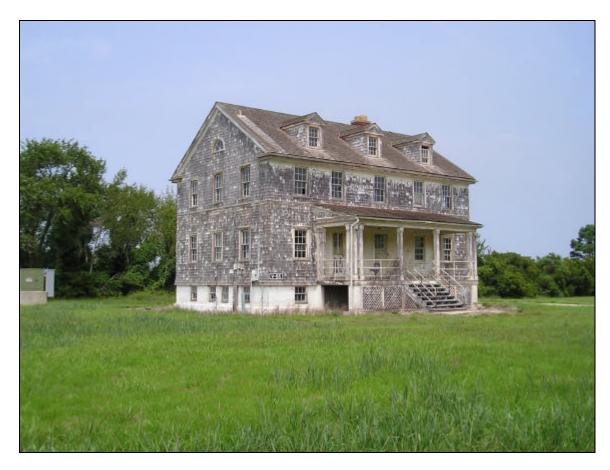
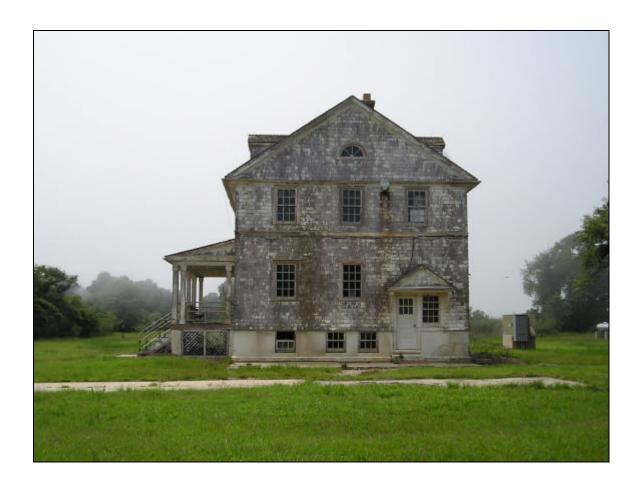
WFF ID# V-65

Located along the main access road towards the northernmost end of Wallops Island, this finely proportioned two-and-one-half story Colonial Revival building originally served as a Coast Guard Station at this location. No longer in Coast Guard ownership, this building now functions as the WEMA Recreational Facility at the Wallops Flight Facility.

The front (east) façade is five bays wide. The station sits on a raised concrete basement. A single 3 over 3 double hung sash window is found near the southeast and northeast corners. A set of 7 steps leads to a landing and the front door. This access is sheltered by a porch, supported by four sets of paired columns. The porch is surmounted by a shallow wood shingled shed roof. At the second floor level are found 5 equally spaced 6 over 6 double hung windows. The entire façade is covered with wood shingles, as are all other facades. Three gable dormers, each with a single 6 over 6 double hung window, are placed symmetrically within the roof.

The rear (west) façade is similar to the front, but with a few variations. At the basement level, two 3 over 3 double hung sash windows are paired closely together at the southwest corner. A single 3 over 3 double hung window is found at the northwest corner. At the first floor level, three 6 over 6 double hung windows are symmetrically placed within the façade. Two smaller 6 over 6 double hung sash windows are placed

between the larger centrally placed window, and the larger window at the northwest corner. At the second floor level, five windows identical to those in the front façade, may be found. A wooden water table is located in a horizontal line at the base of the windows. As with the front façade, three gable dormers are placed symmetrically within the roof. A brick chimney pierces the roof near the northwest corner of the roof.

The south gable end also exhibits four 3 over 3 double hung sash windows at the basement level. Three 6 over 6 double hung windows are symmetrically placed at the first and second floor levels. A wooden water table marks the base of the second floor windows. The roof line is marked by projecting verge boards. Near the apex of the roof is placed a 4 light lunette window.

The north gable end is similar in treatment to the south gable end. At the basement level, three 3 over 3 double hung sash windows begin at the northeast corner and move eastward. On the first floor level, two 6 over 6 double hung sash windows are placed in the first and second bays from the northeast corner. In the third bay, a doorway and single 6 over 6 double hung sash window pierce the façade. These are surmounted by a porch supported by wooden brackets. At the second floor level are three 6 over 6 double hung sash windows, again with a water table. Near the apex of the roof is placed a 4 light lunette window.

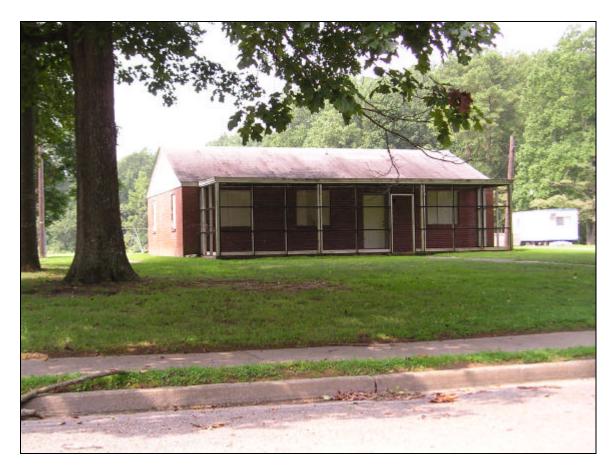
WFF ID# H-16

This one-story gable roofed brick rambler, designated at Unit 11-C, appears to be one of three types of family housing constructed by the U.S. Navy at this location during the mid- to late-1940s. Based on facility management information at the Wallops Flight Facility (WFF), this building was erected in 1947. This property is now in National Aeronautics and Space Administration (NASA) ownership as part of the WFF. As one of approximately 25 individual units, these units now serve as U.S. Coast Guard housing.

This building sits on a slightly elevated grassy area and fronts onto Cartlidge Drive. The front (north) façade is four bays wide. The first, second, and fourth bay from the northeast corner are filled with windows, but these are covered with wooden security panels. An unadorned metal door is located in the third bay. A simple screen porch, supported by thin columns, extends from this façade towards Cartlidge Drive.

The rear (south) façade of this building is identical to the front façade with one exception. Towards the southeast corner is a single-story frame ell which probably serves as a kitchen or bathroom area. (This cannot be verified because no interior access was provided.) This ell is capped by a shallow shed roof.

Both the east and west gable ends are identical in architectural treatment. These are brick at the first floor level. Two windows are centrally placed in each façade. These windows cannot be seen, as they are covered with wood panels for security. The roof gable area above the brick is sheathed in aluminum siding.
